# THE (DRY STONE) BRIDGES OF HILLSBOROUGH COUNTY (NH)

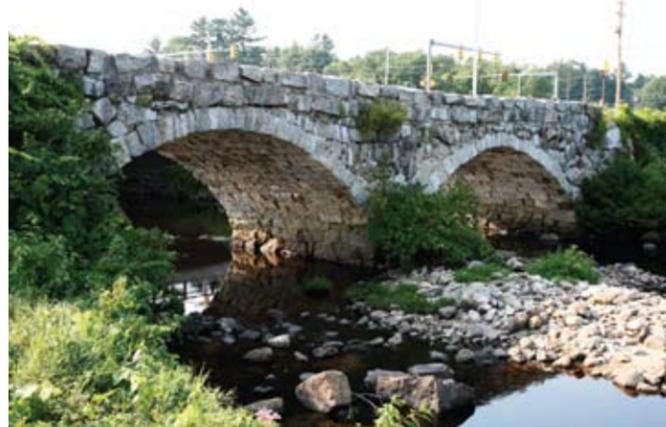
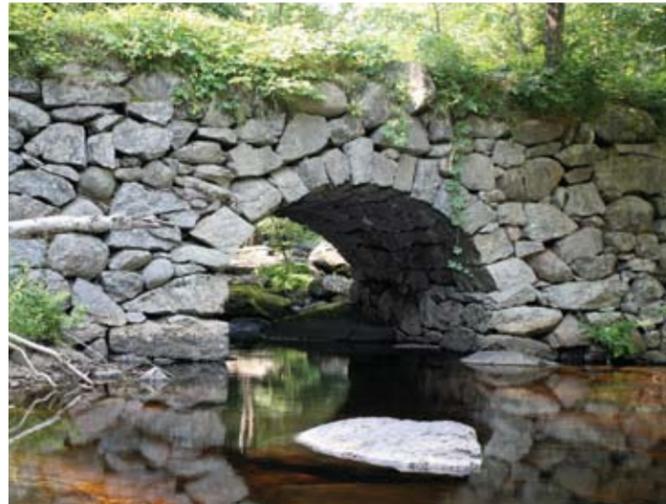
This bridge is noteworthy because of its rise to span ratio: one to four. Most of the others are approximately one to two.

Note that the arches or, more correctly, the vaults in these photos are carefully constructed of a single curving 'course' of well fitted and bonded split granite *voussoirs* (individual arch elements); while the *spandrels* (the space between two arches or between an arch and an abutment) are composed of loosely fitted rubble walling. These slender shell-like arch/vault units are bearing the combined weight of the spandrels, the kerb wall containing the roadway, the mass of the roadway itself and the vehicles that pass over it—and doing it gracefully.
